**Flood Control Project Maintenance
Levee Inspections**
LMA District Cover Sheet
Spring 2020 Levee Inspection Results

Sutter Maintenance Yard East Levee Sacramento River

Spring 2020 Levee Inspection Results

| Waterway | | | Bank | Unit Miles |
|--|---|---|---|---|
| Unit No. 01 Sacramento River | | | Left | 19.85 |

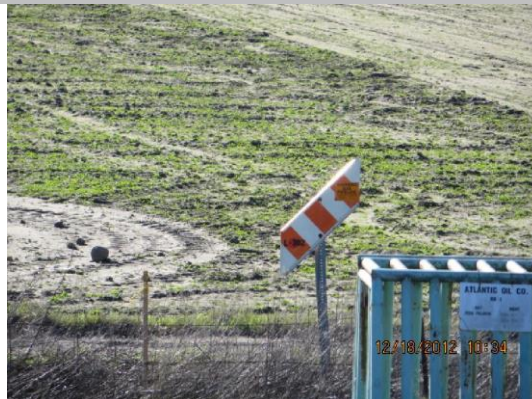
Photo 2 of 3 : UCIP_SP_2020_55624_47475.jpg

LS view: gasoline indicator about 100 ft away from the levee.

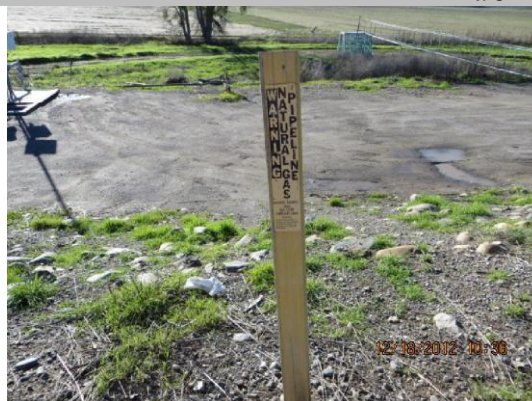
Photo 3 of 3 : UCIP_SP_2020_55624_47474.jpg

LS view: gasline indicator

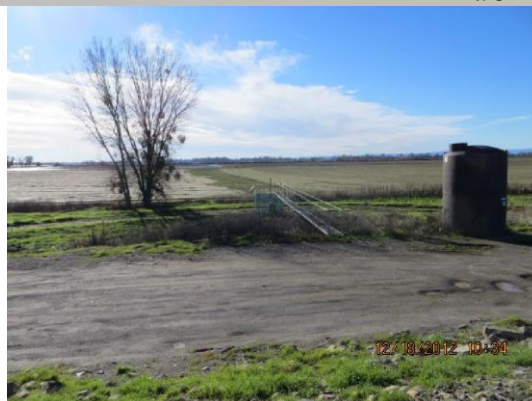
Photo 1 of 3 : UCIP_SP_2020_55625_47468.jpg

DS_ID:17536
 FS_ID:55625
 EP_NO: 15821
 Repair Type: Non-Urgent
 Crossing Status: Indicator Found
 UCIP Comments: 08/05/2019 Crossing has been updated from No Action Needed to Non-Urgent; need maintenance records to determine current status of line. Recommend auditing this record to confirm authorized lines through the levee and appurtenances associated with line. (O. Magana - DWR UCIP)06/03/2016 Crossing appears to be in good condition.04/06/2015 Same as last inspection.07/07/2014 Same as last inspection.12/19/2013 Same as last inspection.07/22/2013 Same as last inspection.
 FIELD_STRUCT_DESC: 2 of 3. 4-inch natural gas pipeline under both levees. 12-inch distance between the pipes and two inches on either side of the trench. A gas line marker found on the landside (LS) for all 3 gas lines. (Permit No. 15821, 1991 - Phoenix Oil & Gas).
 FS Date: 8/5/2019 3:19:00 PM

LS view: overview

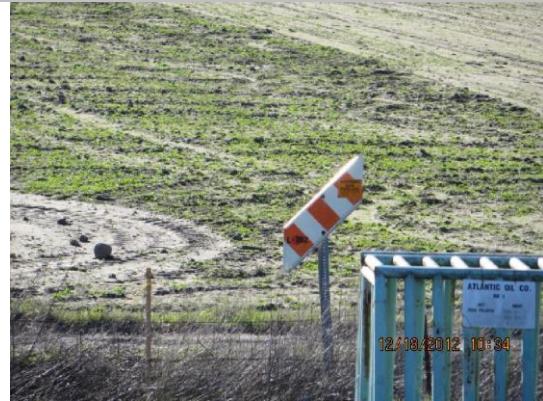
Photo 2 of 3 : UCIP_SP_2020_55625_47467.jpg

LS view: gasline indicator about 100 ft away

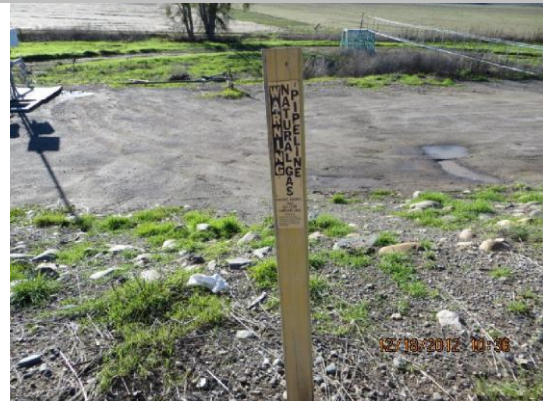
Photo 3 of 3 : UCIP_SP_2020_55625_47466.jpg

LS view: gasline indicator

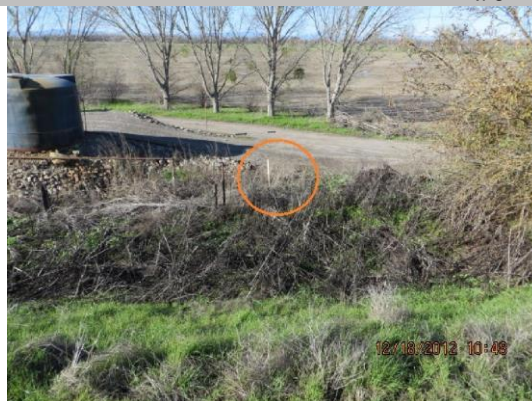
Photo 1 of 3 : UCIP_SP_2020_55627_47480.jpg

DS_ID:17531
 FS_ID:55627
 EP_NO: 13534
 Repair Type: Non-Urgent
 Crossing Status: Indicator Found
 UCIP Comments: 08/05/2019 Crossing remains Non-Urgent due to limited access to line; need maintenance records to determine current status of line. (O. Magana - DWR UCIP)06/03/2016 Crossing appears to be in good condition.04/06/2015 Same as last inspection. May need to add more substantial gas line markers.07/07/2014 Same as last inspection.12/19/2013 Same as last inspection.07/22/2013 Same as last inspection.
 FIELD_STRUCT_DESC: 2.5-inch asphalt coated steel gas pipeline through the levee, 2.5 feet below the crown. A gas line marker found on the landside (LS). (Permit No. 13534, 1982 - Texaco, Incorporated).
 [Additional Reference(s): DWR Levee Log, 2002].
 FS Date: 8/5/2019 3:23:00 PM

LS view: overview gasline indicator

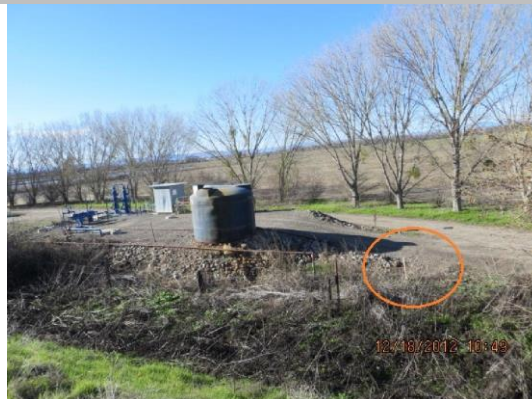
Photo 2 of 3 : UCIP_SP_2020_55627_47479.jpg

LS view: overview gasline indicator

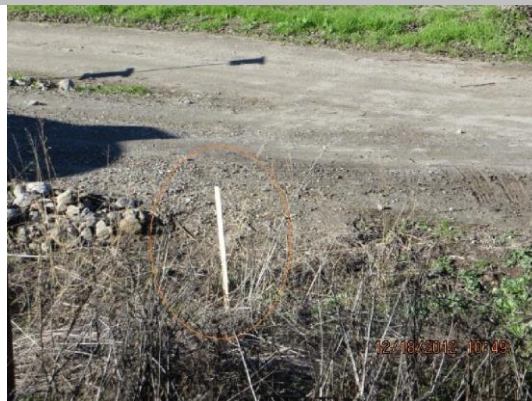
Photo 3 of 3 : UCIP_SP_2020_55627_47478.jpg

LS view: gasline indicator

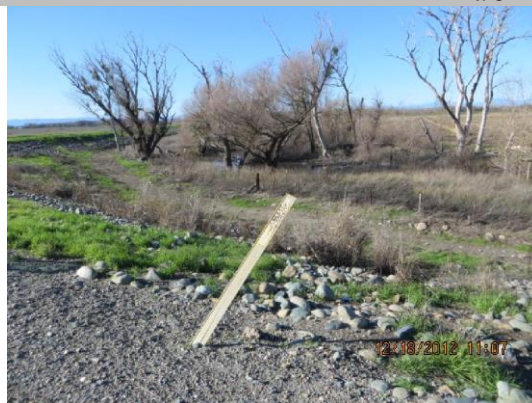
Photo 1 of 3 : UCIP_SP_2020_55628_47482.jpg

| DS_ID:17556 FS_ID:55628 EP_NO: 15821 Repair Type: Non-Urgent Crossing Status: Indicator Found UCIP Comments: 08/05/2019 Crossing has been updated from No Action Needed to Non-Urgent; need maintenance records to determine current status of line. (O. Magana - DWR UCIP)06/03/2016 Crossing appears to be in good condition.04/06/2015 Same as last inspection. May need to add additional gas line markers.07/07/2014 Same as last inspection.12/19/2013 Same as last inspection.07/22/2013 Same as last inspection. FIELD_STRUCT_DESC: 1 of 3. 4-inch natural gas pipeline under both levees. 12-inch distance between the pipes and two inches on either side of the trench. A gas line marker found on the landside (LS) for all 3 gas lines. (Permit No. 15821, 1991 - Phoenix Oil & Gas). FS Date: 8/5/2019 3:26:00 PM | | | | | | |

LS view: gasoline indicator

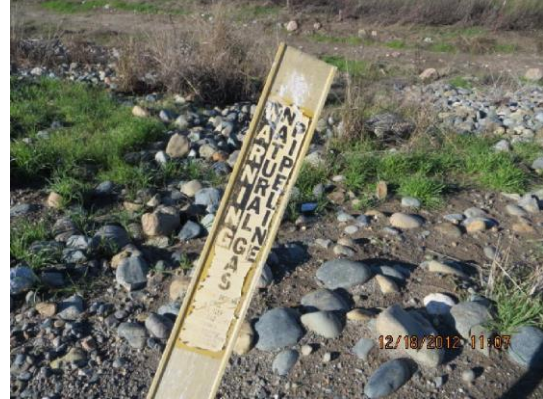
Photo 2 of 3 : UCIP_SP_2020_55628_47481.jpg

LS view: gasline indicator close view

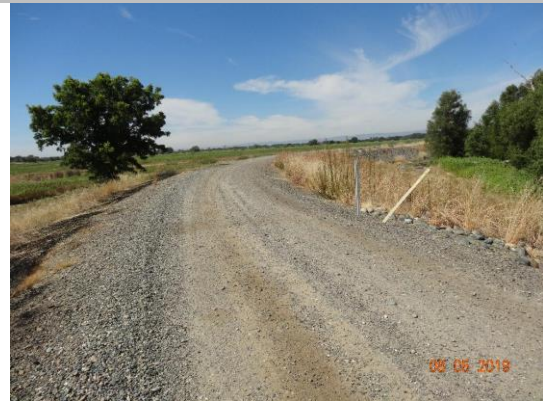
Photo 3 of 3 : UCIP_SP_2020_55628_82213.jpg

Overview of levee crown looking d/s towards pipe crossing.

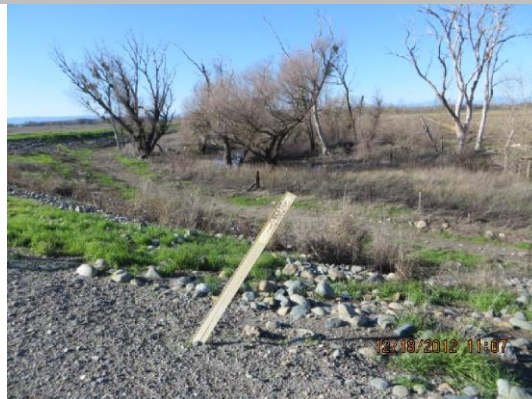
Photo 1 of 3 : UCIP_SP_2020_55629_47484.jpg

| DS_ID:17557 FS_ID:55629 EP_NO: 15821 Repair Type: Non-Urgent Crossing Status: Indicator Found UCIP Comments: 08/05/2019 Crossing has been updated from No Action Needed to Non-Urgent; need maintenance records to determine current status of line. (O. Magana - DWR UCIP)06/03/2016 Crossing appears to be in good condition.04/06/2015 Same as last inspection. May need to add additional gas line markers.07/07/2014 Same as last inspection.12/19/2013 Same as last inspection.07/22/2013 Same as last inspection. FIELD_STRUCT_DESC: 2 of 3. 4-inch natural gas pipeline under both levees. 12-inch distance between the pipes and two inches on either side of the trench. A gas line marker found on the landside (LS) for all 3 gas lines. (Permit No. 15821, 1991 - Phoenix Oil & Gas). FS Date: 8/5/2019 3:27:00 PM | | | | | | |

LS view: gasline indicator

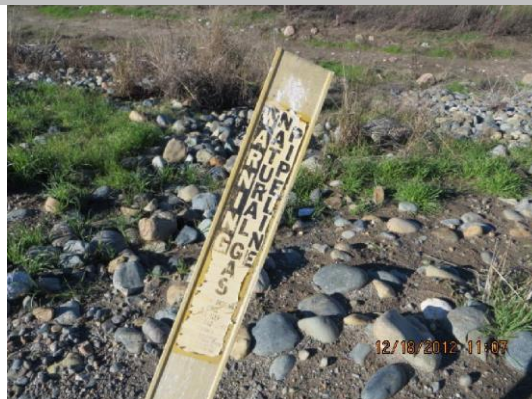
Photo 2 of 3 : UCIP_SP_2020_55629_47483.jpg

LS view: gasline indicator close view

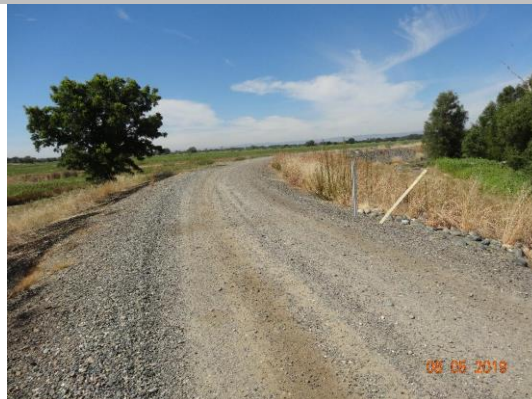
Photo 3 of 3 : UCIP_SP_2020_55629_82217.jpg

Overview of levee crown looking d/s towards pipe crossing.

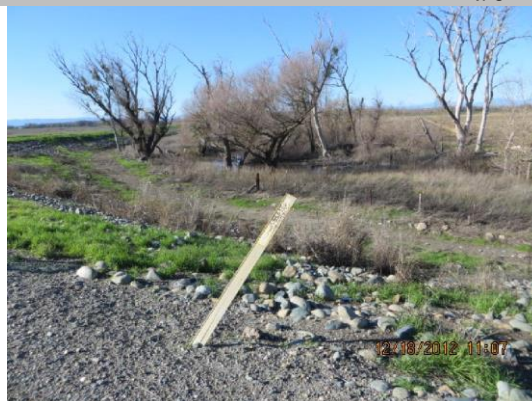
Photo 1 of 3 : UCIP_SP_2020_55630_47486.jpg

DS_ID:17558
 FS_ID:55630
 EP_NO: 15821
 Repair Type: Non-Urgent
 Crossing Status: Indicator Found
 UCIP Comments: 08/05/2019 Crossing has been updated from No Action Needed to Non-Urgent; need maintenance records to determine current status of line. (O. Magana - DWR UCIP)06/03/2016 Crossing appears to be in good condition.04/06/2015 Same as last inspection. May need to add additional gas line markers.07/07/2014 Same as last inspection.12/19/2013 Same as last inspection.07/22/2013 Same as last inspection.
 FIELD_STRUCT_DESC: 3 of 3. 4-inch natural gas pipeline under both levees. 12-inch distance between the pipes and two inches on either side of the trench. A gas line marker found on the landside (LS) for all 3 gas lines. (Permit No. 15821, 1991 - Phoenix Oil & Gas).
 FS Date: 8/5/2019 3:29:00 PM

LS view: gasline indicator

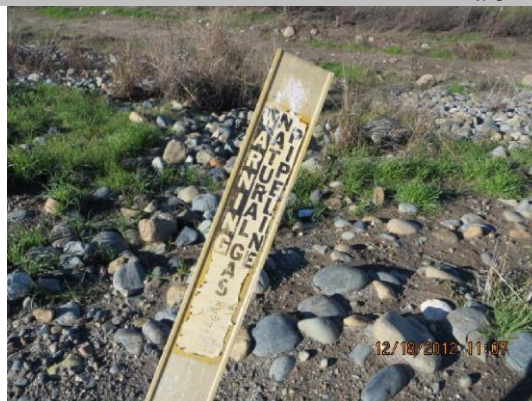
Photo 2 of 3 : UCIP_SP_2020_55630_47485.jpg

LS view: gasline indicator close look

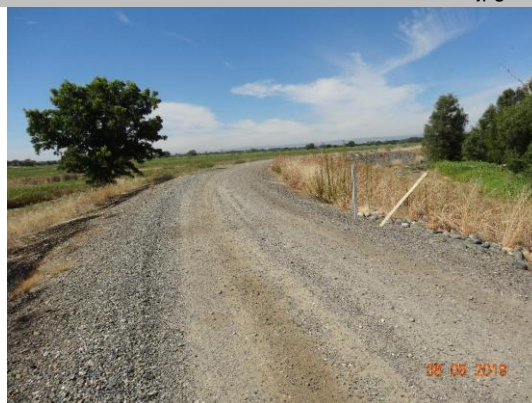
Photo 3 of 3 : UCIP_SP_2020_55630_82221.jpg

Overview of levee crown looking d/s towards pipe crossing.

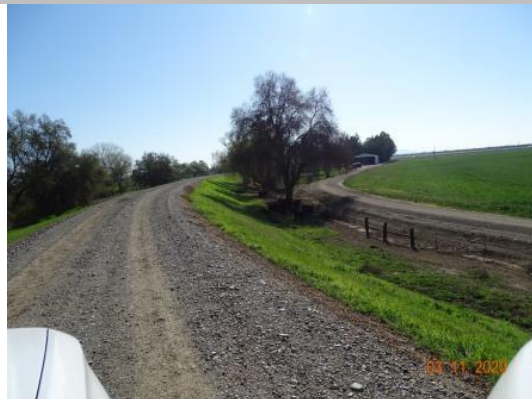
Photo 1 of 1 : SP_2020_ST0003_267_2_20200313_00004.jpg

| Good vegetation control on both landside and waterside slopes. | | | | | |

View of the vegetation on the landside slope. Spring 2020.

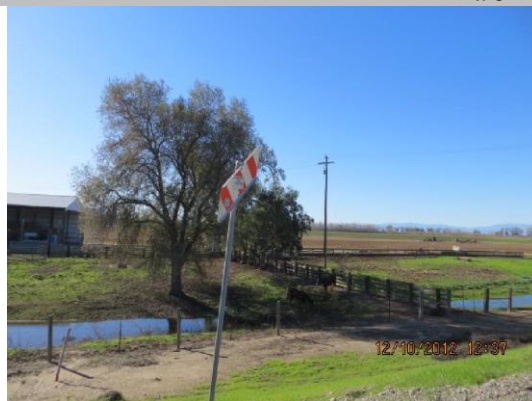
Photo 1 of 3 : UCIP_SP_2020_55631_47487.jpg

| DS_ID:17559 FS_ID:55631 EP_NO: 2638 Repair Type: Non-Urgent Crossing Status: Indicator Found UCIP Comments: 08/01/2019 Crossing has been updated from No Action Needed to Non-Urgent; need maintenance records to determine current status of line. (O. Magana - DWR UCIP)06/03/2016 Crossing appears to be in good condition.04/06/2015 Same as last inspection.07/07/2014 Same as last inspection.12/19/2013 Same as last inspection.07/22/2013 Same as last inspection. FIELD_STRUCT_DESC: 4.5-inch asphalt coated steel gas pipeline through the levee, 3.0 feet below the crown. Gas line marker on the landside (LS). (Permit No. 2638, 1957 - Pacific Gas and Electric Company). [Additional Reference(s): DWR Levee Log, 2002]. FS Date: 8/1/2019 1:56:00 PM | | | | | | |

LS view: overview gasline indicator

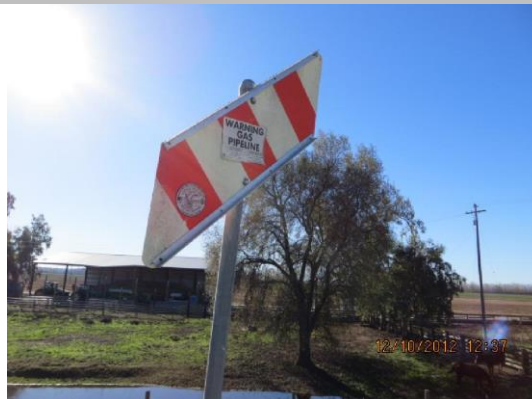
Photo 2 of 3 : UCIP_SP_2020_55631_47488.jpg

LS view: gasoline indicator

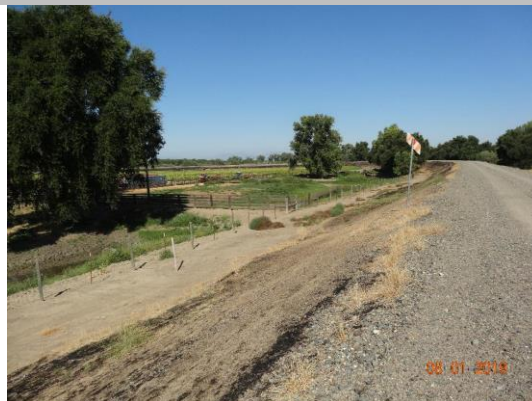
Photo 3 of 3 : UCIP_SP_2020_55631_82225.jpg

LS view: overview of LS slope.

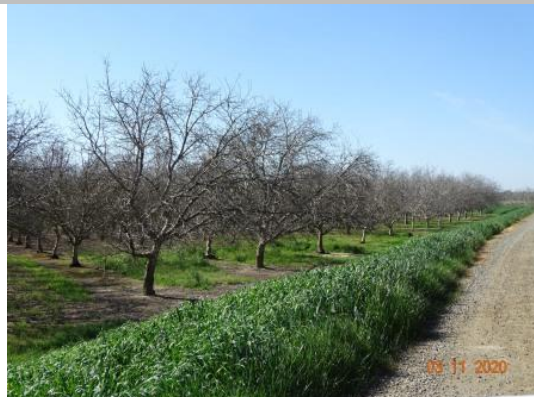
Photo 1 of 1 : SP_2020_ST0003_268_7_20200313_00006.jpg

View of the vegetation on the landside slope. Spring 2020.

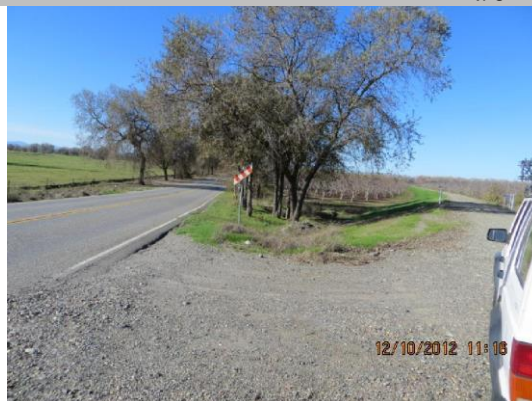
Photo 1 of 3 : UCIP_SP_2020_55632_47489.jpg

| DS_ID:17562 FS_ID:55632 EP_NO: 3718 Repair Type: Non-Urgent Crossing Status: Indicator Found UCIP Comments: 08/05/2019 Crossing has been updated from No Action Needed to Non-Urgent; need maintenance records to determine current status of line. (O. Magana - DWR UCIP)06/03/2016 Crossing appears to be in good condition.04/06/2015 Same as last inspection.07/07/2014 Same as last inspection.12/19/2013 Same as last inspection.07/22/2013 Same as last inspection. FIELD_STRUCT_DESC: 6-inch steel gas pipeline through the levee, 2.5 ft below the crown. Gas line marker on the waterside (WS) toe. (Permit No. 3718, 1961 - Pacific Gas and Electric Company). [Additional Reference(s): DWR Levee Log, 2002]. FS Date: 8/5/2019 3:30:00 PM | | | | | | |

WS view: gasoline indicator

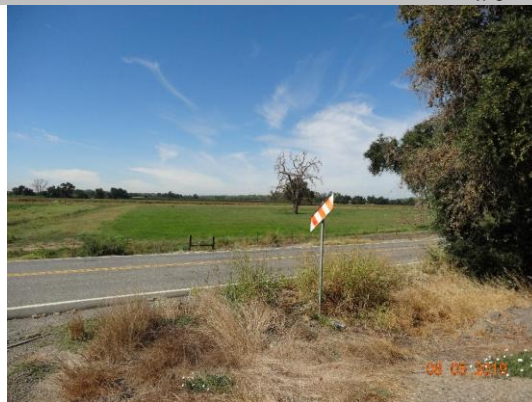
Photo 2 of 3 : UCIP_SP_2020_55632_82230.jpg

WS view: gas line paddle marker off River Road on WS.

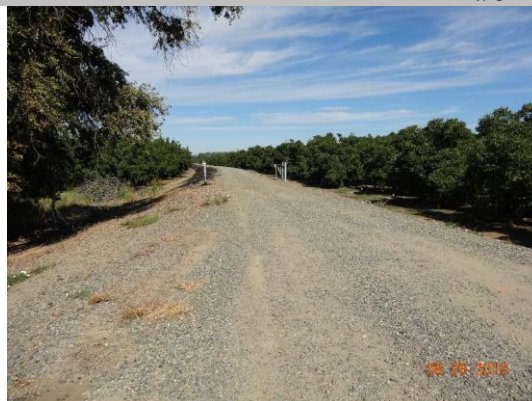
Photo 3 of 3 : UCIP_SP_2020_55632_82231.jpg

Overview of levee crown looking d/s.
